**PUGET SOUND
NAVAL SHIPYARD
BREMERTON
FLEET MOORINGS
UNDERWATER
INSPECTION
REPORT**

OCTOBER 1983

OCEAN ENGINEERING
AND CONSTRUCTION PROJECT OFFICE
CHESAPEAKE DIVISION
NAVAL FACILITIES ENGINEERING COMMAND
WASHINGTON, D.C. 20374

FPO-1-83 (38)

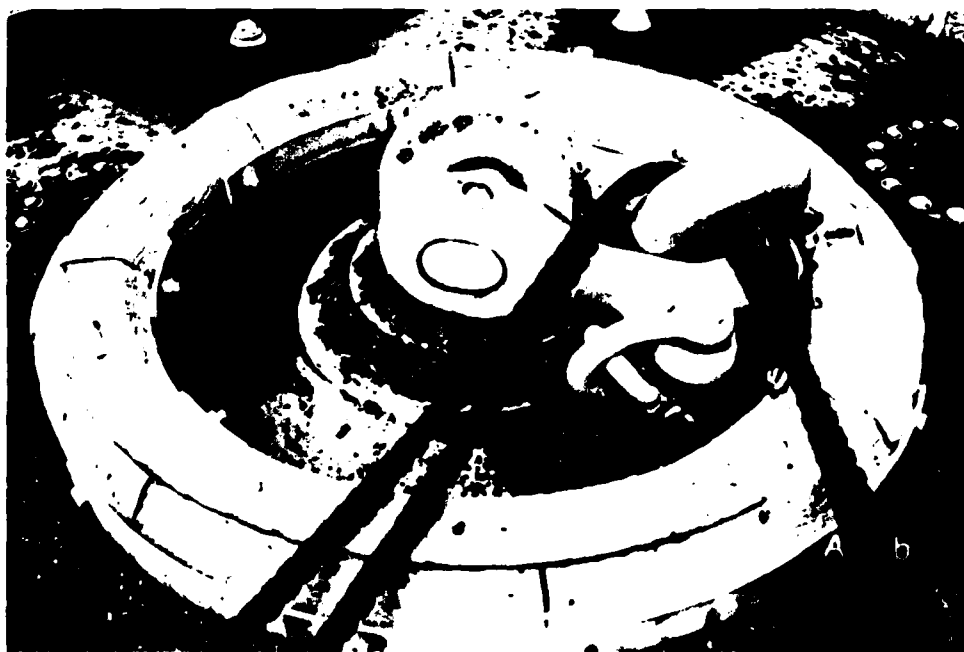
This is a 12-foot-diameter peg-top buoy with a 2 3/4-inch-thick tension bar and 4 feet of freeboard. The buoy was recently refurbished and is in good condition. The chaffing rails have metal plates attached.

Mooring A-12 – Top Jewelry in Good Condition

- o Due to undersized (2 1/2-inch) riser chain, mooring A-12 should be reclassified as a Class B mooring.
- o Due to undersized (2 1/4-inch) riser chain, mooring A-13 should be reclassified as a Class C mooring.
